AN UNKNOWN LATE PŘEMYSLID REBUILDING OF THE PRESBYTERY OF ST. FRANCIS CHURCH IN ST. AGNES MONASTERY IN PRAGUE

The Discovery of a Timber Reinforcement from after 1303 and Its Parallels

FILIP FACINCANI

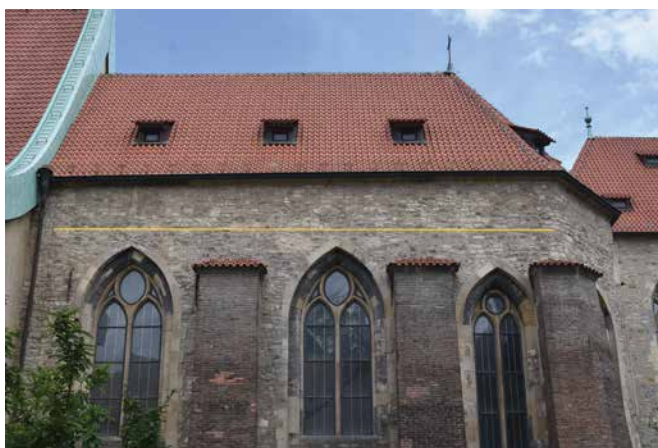
Fig. 7. St. Agnes Monastery, presbytery of the Church of St. Francis. View of the south-west corner of the attic at the junction of the southern outer wall of the presbytery made of roughly shaped stone and the eastern gable of the nave of the church of St. Francis made of regular stone blocks from the 1230s (photo by the author, 2024).

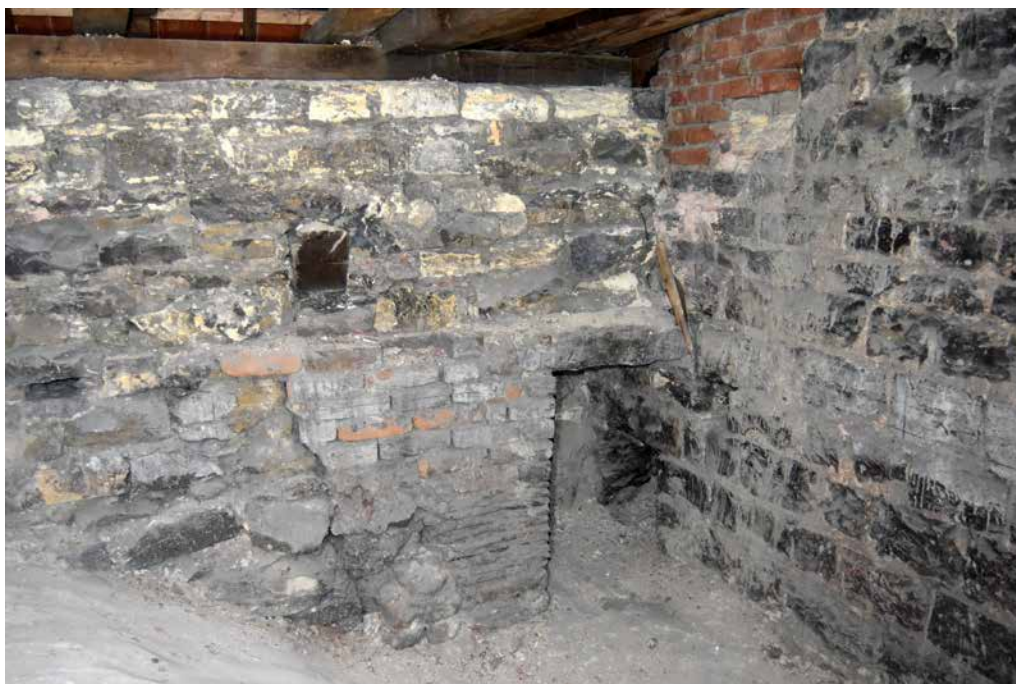
Fig. 8. St. Agnes Monastery, attic of the presbytery of the Church of St. Francis. The face of the south outer wall above the vaults with the cut-off remnant of the timber clamp (photo unedited).

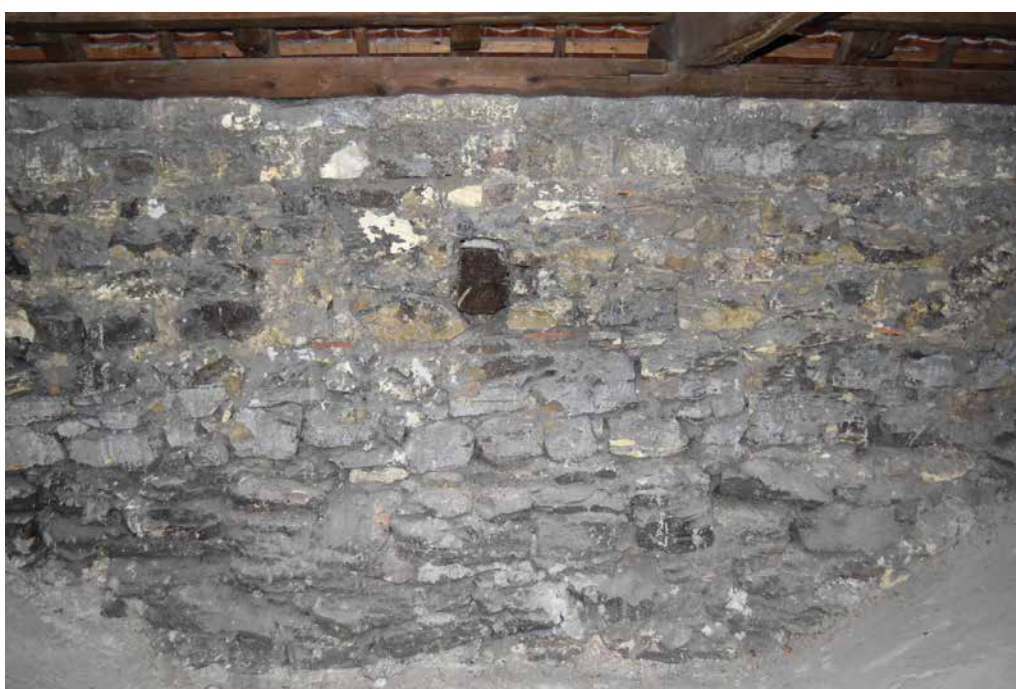
Fig. 10. The same view as in Fig. 8, the increased colour contrast highlights the interface between layers **A** (114 cm from the vault's trough), **B** (60 cm) and **C** (32 cm) and the height position of the timber clamp (c. 17 × 23 cm) in the masonry of layer **B**. The dark colouration and pinkish colour of the stone used in layer **A** and the yellowish colour of the stone used in layer **B** are evident (photo by the author, 2024).

The nature of the masonry changes above layer A. Subsequent **layer B** is separated from it by a distinctive bedding joint, defining the beginning of the reconstruction after 1300 (Figs 9, 10). It is also made of roughly worked marlstone blocks, but this time these are more precisely finished. The classic yellow colour of the marlstone proves that the layer A has been affected by fire – but the layer B has not. The bedding joint between these two layers was filled with fragments of floor and roof tiles all around the outside, probably recycled remains of the original roofing. It is in layer B that several fragments of the unrecorded timber reinforcement can be found, preserved in situ. In the southern wall five headers of cut massive beams are preserved and facing inwards (Fig. 3), which correspond to the either empty or later filled sockets in the northern wall. This indicates that the timbers were first cut on the south side and removed from the north sockets at the time of dismantling (probably after 1689). In two of these northern sockets, moreover, there is a visible section of a continuous internal beam, running along the course of the outer wall and functioning as a *de facto* wall plate (Figs 14A, B, D). From these preserved fragments, it is evident that the tie beams were jointed to the continuous internal beam and thus these wooden fragments are remnants of the timber reinforcement.

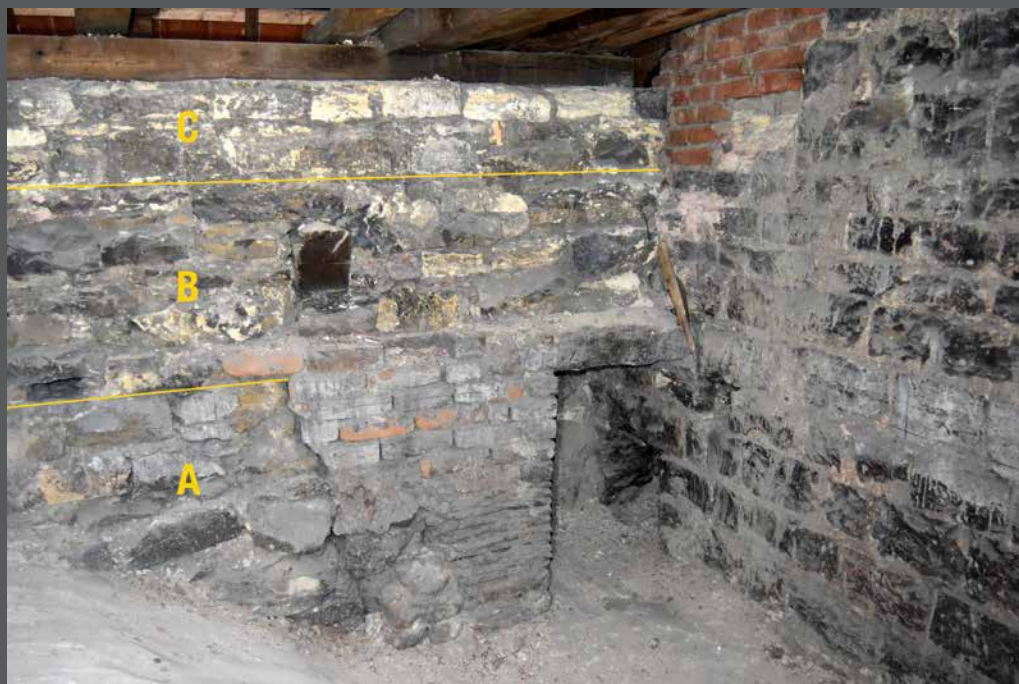
Fig. 9. The same view as in Fig. 7 with the interface between phases **A**, **B** and **C** marked (photo und designation by the author, 2024).

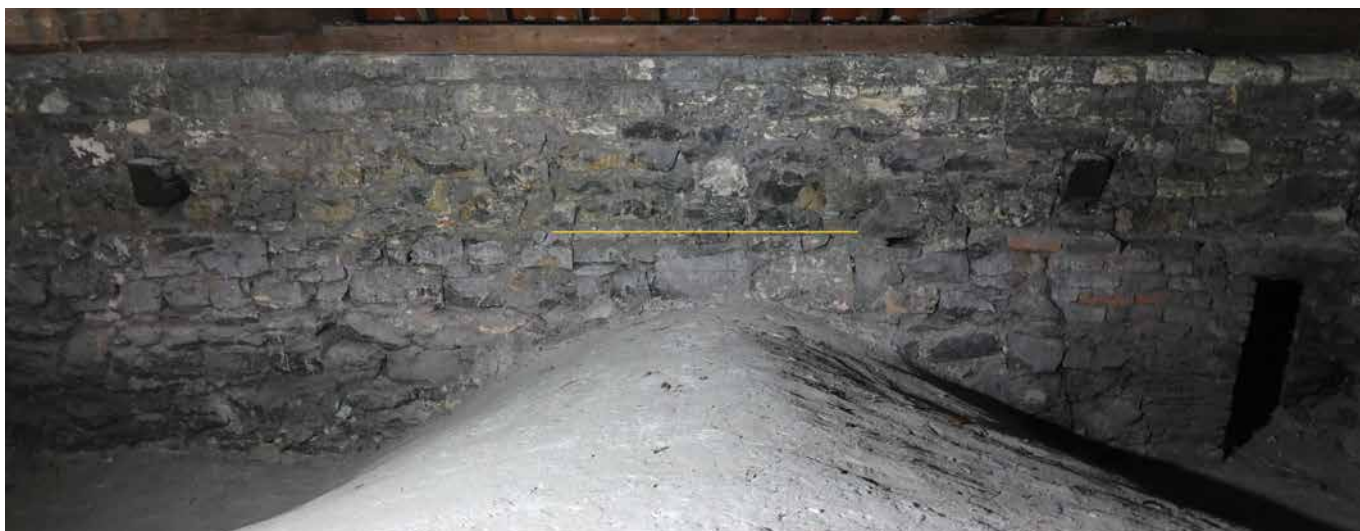
Fig. 11. St. Agnes Monastery, attic of the presbytery of the Church of St. Francis. The top of the vault and the layer **A** from the first building phase (1238–1245), the bedding joint of layer **B** from the reconstruction of the timber reinforcement from after 1300 marked in **yellow** (photo by the author, 2024).

The lower **layer A** preceded the construction of the vault and thus ends slightly above its top (Figs 11, 12). The surface of its stone blocks is coloured dark grey to black, but where the stone has degraded, its pink colour is evident (Fig. 13), indicating that the layer A has been exposed to fire.² The same damage can be seen on the adjacent face of the east gable of the St. Francis nave, built during the very first building phase (before 1234) and facing the presbytery attic.

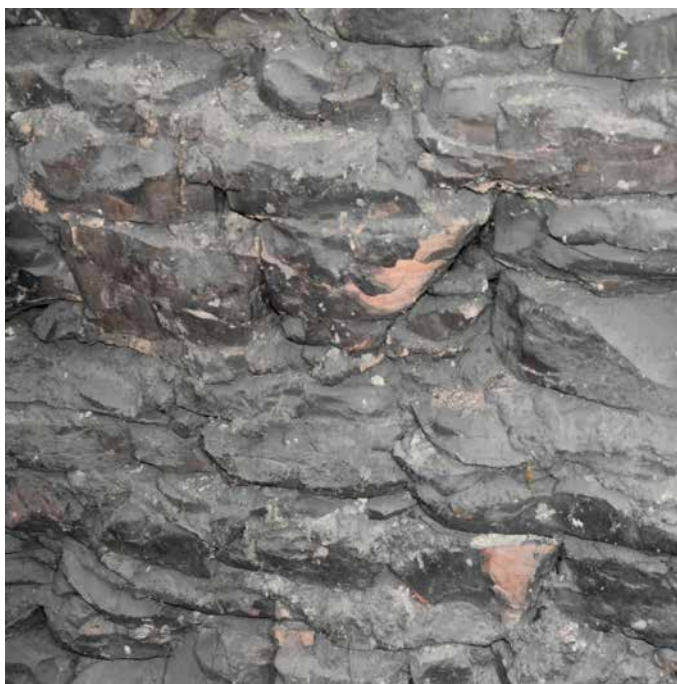
Fig. 13. St. Agnes Monastery, attic of the presbytery of the Church of St. Francis. The pinkish colour of the stone blocks in layer A shows that this layer was damaged by fire (photo by the author, 2024).

The nature of the lower layer A suggests that the building was exposed to fire before the reconstruction at the very start of the 14th century. In view of the newly obtained dating of the reconstruction, it is possible to relate two known events to this date — namely the fire of the Old Town of Prague in 1291 and the sudden disaster before 1343. The latter was considered by D. Líbal (LÍBAL/HYZLER/LANCINGER 1964, 58) as the impulse for the massive reconstruction of the monastery during the 14th century. The relevance of the former cannot be ruled out, although it seems unlikely that the reconstruction of such an exposed site would have taken place with a delay of ten years. The later date needs to be subjected to a more detailed analysis, and this shows that it does not refer to the St. Agnes monastery at all.

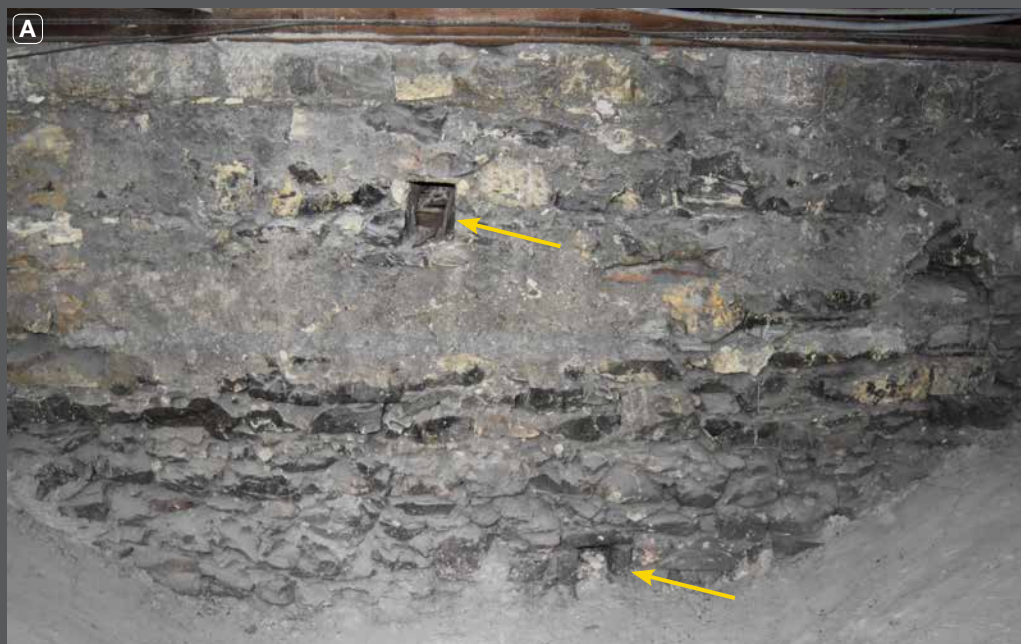
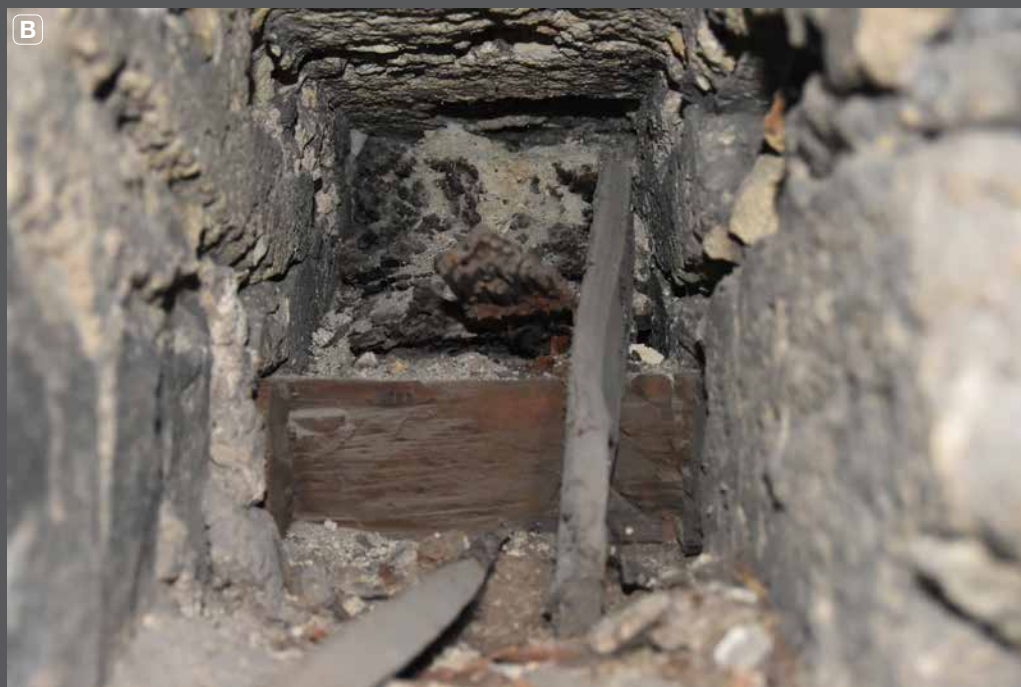
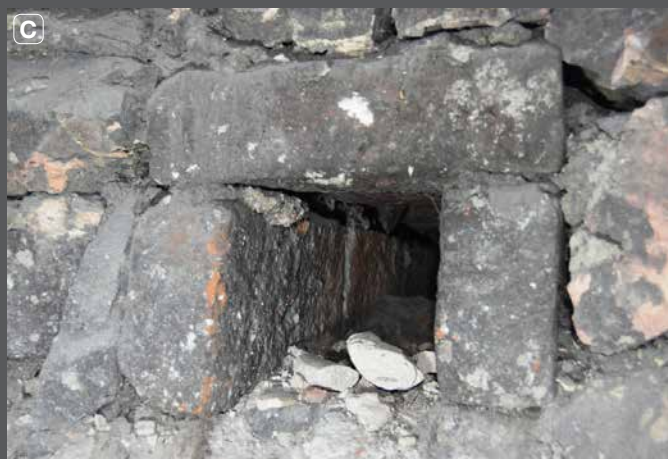
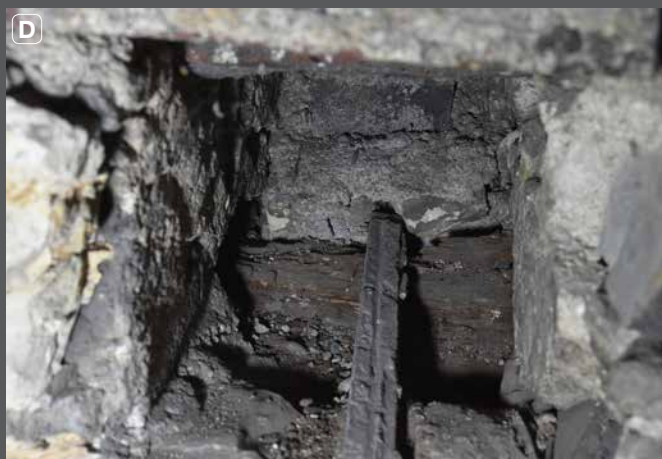
Fig. 14. St. Agnes Monastery, attic of the presbytery of the Church of St. Francis. The face of the northern outer wall of the longitudinal part above the vault.

A – brick putlog hole for scaffolding timber in the vault (layer **A**), empty socket for timber clamp in layer **B** with clear section of continuous timber;

B – the westernmost of the sockets with a visible fragment of continuous timber (photo by author, 2024);

C – brick putlog hole for scaffold timber;

D – the easternmost of the sockets in the northern outer wall of the longitudinal part of the presbytery (photo by author, 2024).

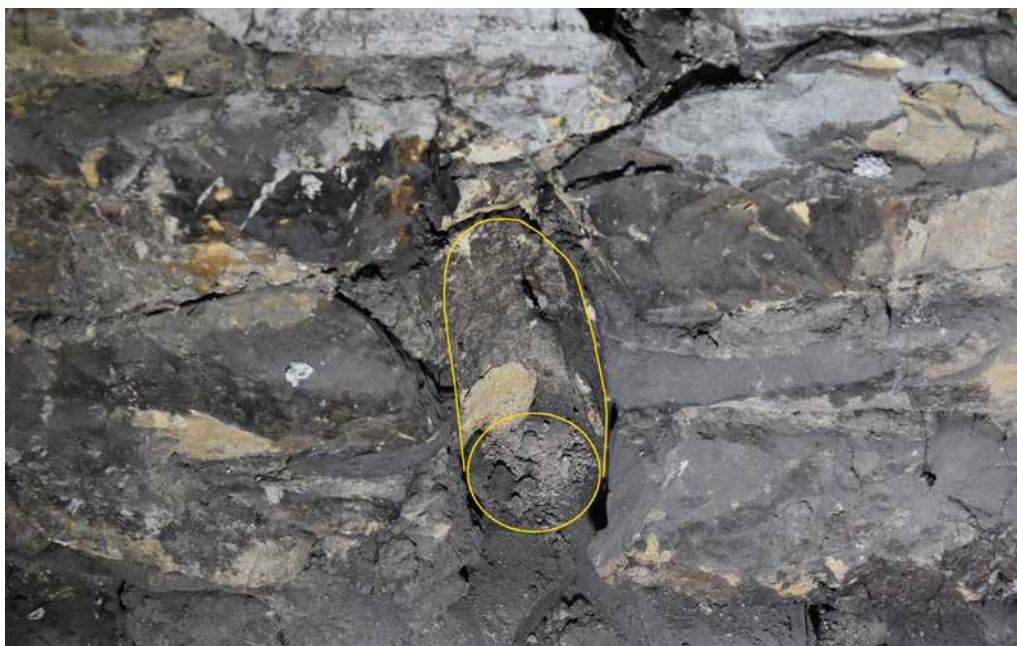
Fig. 15. St. Agnes Monastery, attic of the presbytery of the Church of St. Francis. One of the two sockets of wooden logs in the axial field of the polygon of the presbytery (photo by the author, 2024).

There is also a pair of sockets within the polygonal apse, this time consisting of wooden logs with a diameter of approximately 15 cm (Figs 15, 16). It is clear from the masonry that the logs were added to the top of the masonry of layer A and walled up by the masonry of layer B, i.e. they are contemporary with the latter. However, the logs were at an angle of approximately 20° with the face of the masonry above, which thereby precludes their being applied in a timber reinforcement itself (see below).
